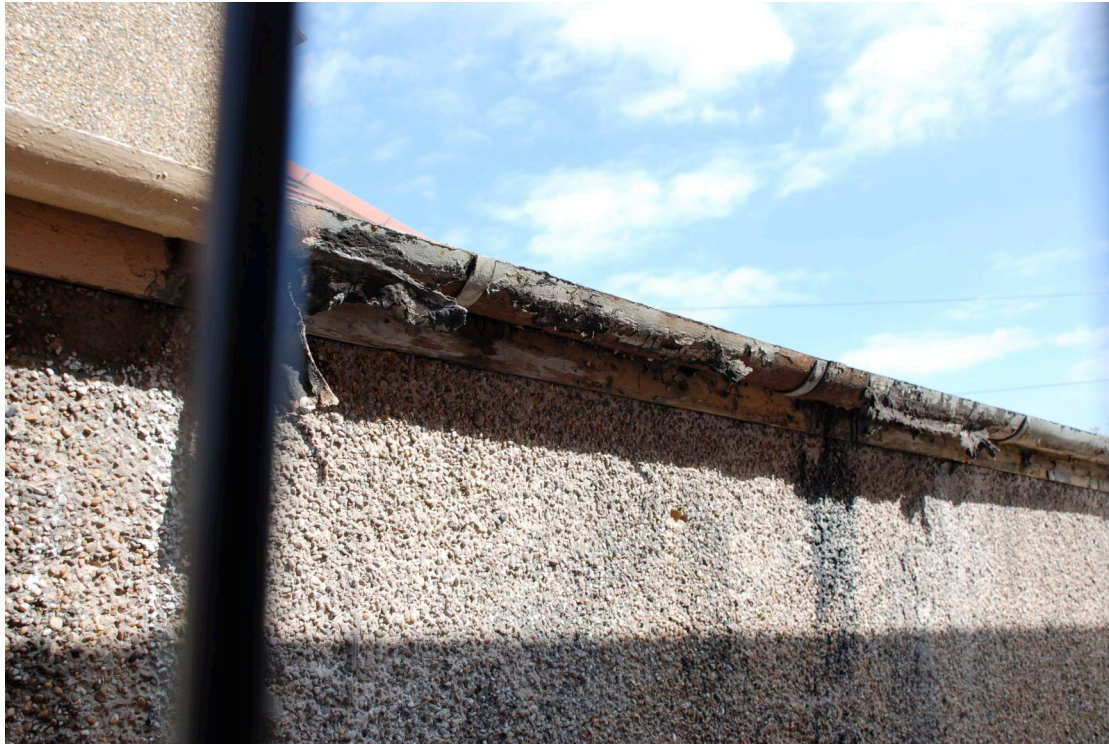
22 Defective gutter south side of garage

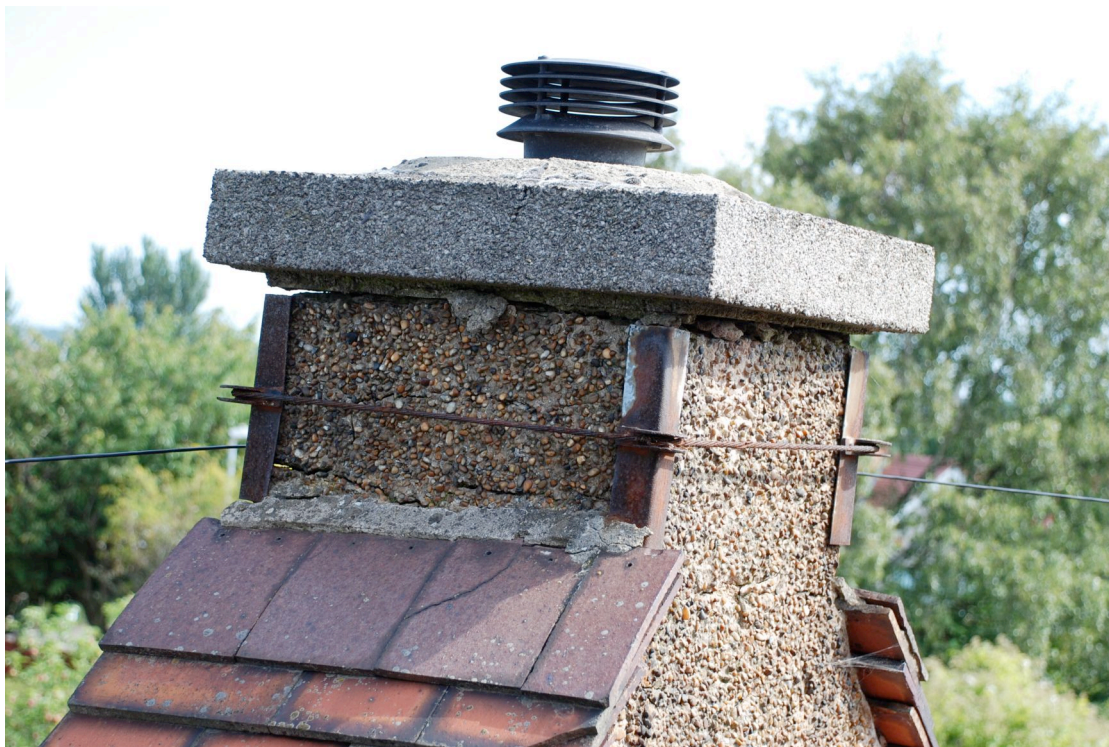
23 North east chimney, cracked render & defective pointing under cope

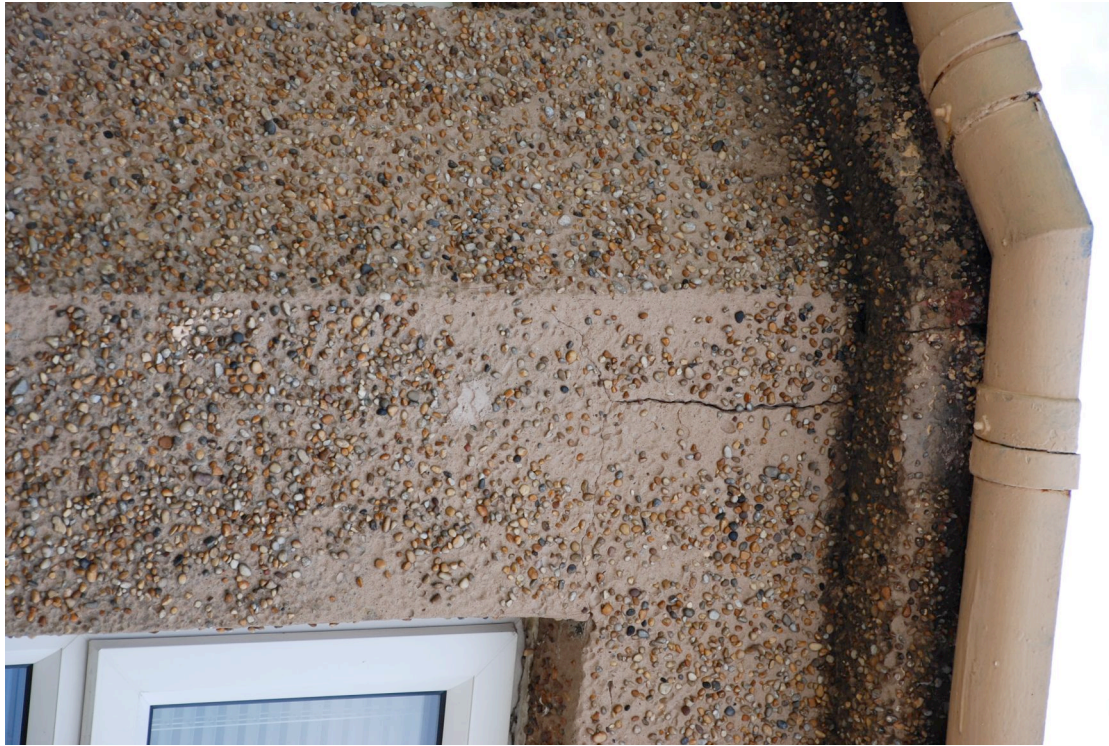
26 Front window bay, cracked render (typical)

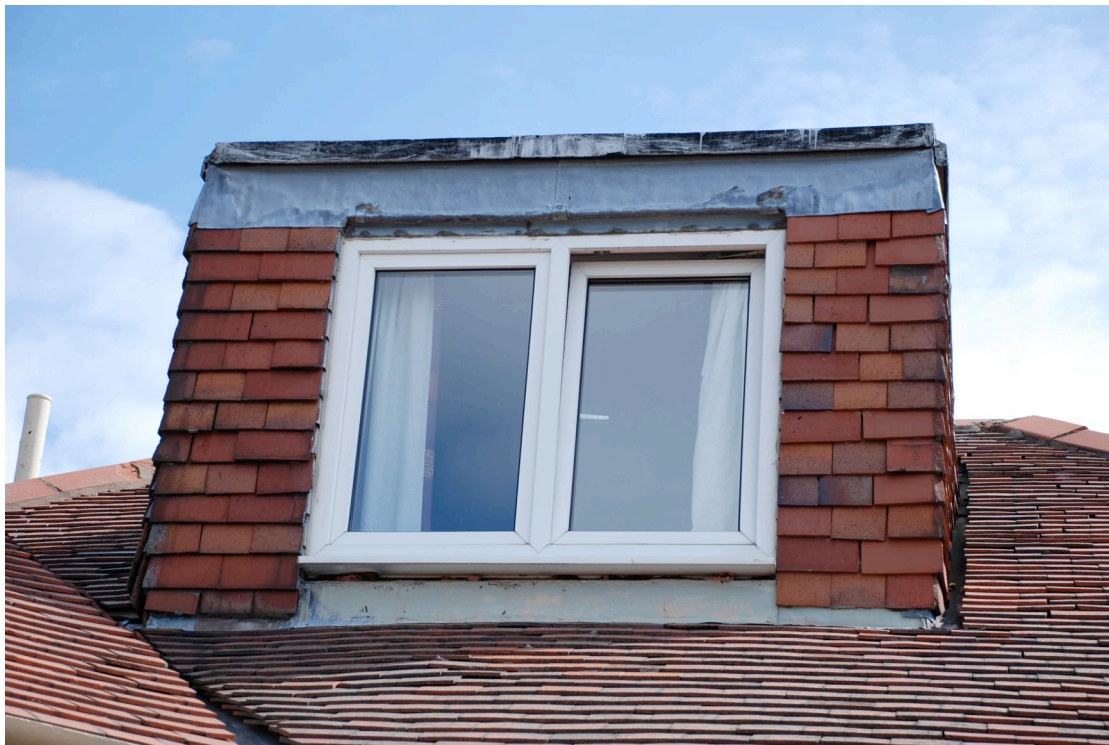
27 Front dormer, defective pointing under cill

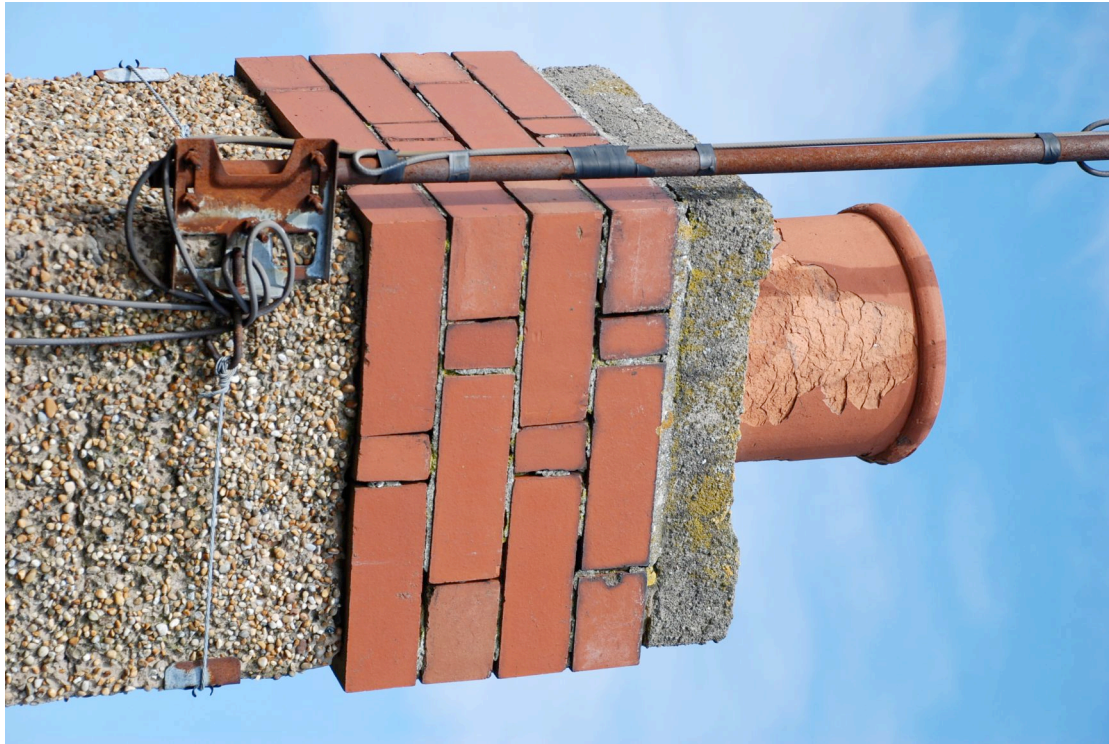
24 North west chimney, defective brick pointing & can

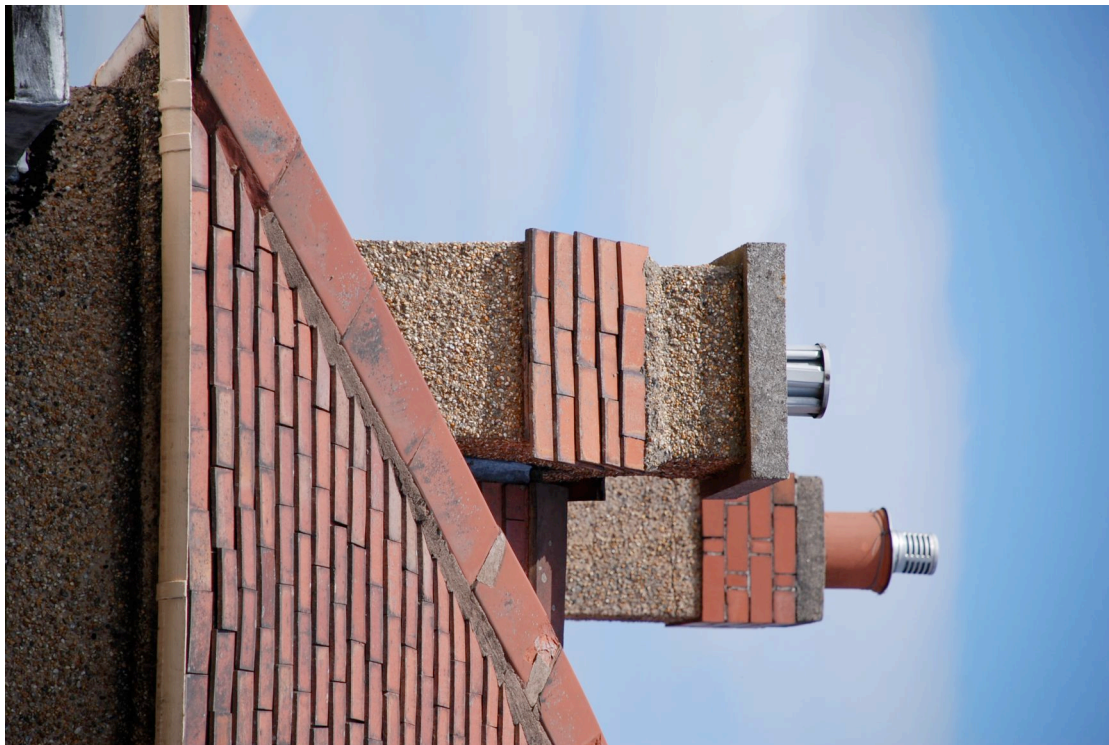
25 South west chimney (rear of photo), defective brick pointing
